## Summary of Rollover Crash Tests

Louise A. Carter  
Joseph A. Pellettiere

June 2002

Final Report for the Period October 1992 to September 1997

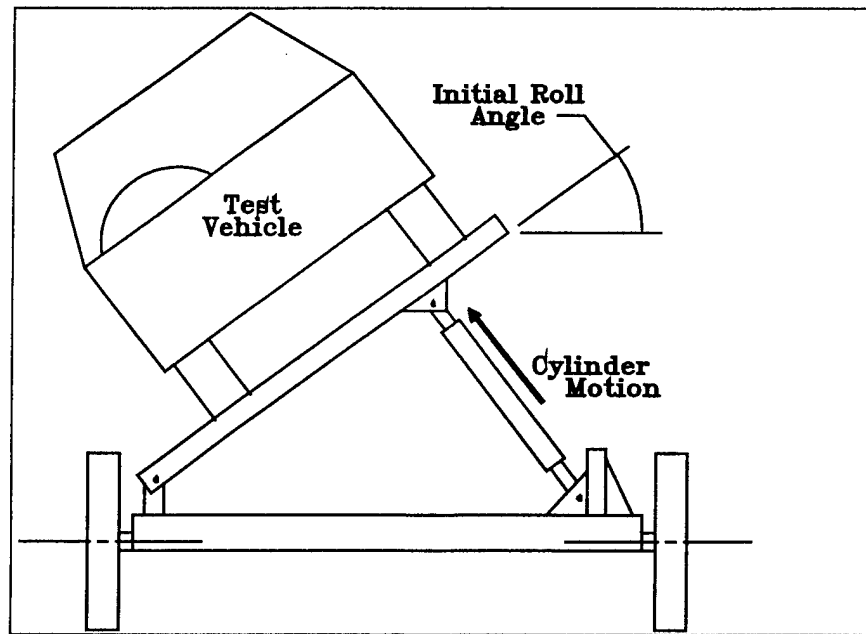
Figure1. Test Vehicle Mounted on the Rollover Test Device

The vehicles in the RTD tests were mounted on the RTD, as shown in Figure 1, with an initial roll angle of 30 degrees. The RTD was towed by cable along a guide-rail to obtain a specified initial velocity. After reaching the start point, the launch sequence was started. First, chains attaching the vehicle to the platform were released, the pneumatic cylinders were actuated producing angular rotation of the platform and vehicle, and the RTD was decelerated. This resulted in the vehicle being thrown clear of the RTD with an initial linear and angular velocity. The vehicle was mounted with its frame directly supported on the platform to avoid effects from the tires and suspension system, providing better repeatability between tests. The RTD wheels were designed so that they can be rotated to allow the RTD and the test vehicle to be crabbed at an initial yaw angle (Figure 2). This feature of the RTD permits its use over a wide range of rollover crashes. Figure 3 shows the 1988 Ford Bronco from test D10 mounted on the RTD with  $-45^\circ$  yaw. In the initial ten RTD tests on a concrete surface, many of the vehicles did not complete a full roll. Since accident investigation data show that the greater amount of roll, the greater potential for injury, a rubber mat was installed on the surface in order to increase friction and therefore increase the likelihood of multiple rolls, as well as to standardize the properties of the initial impacting surface. The RTD was originally designed to handle small to mid-sized automobiles. For the RTD to handle test vehicles of greater weight and to provide greater angular velocity, the original pneumatic cylinders were replaced with larger cylinders after the sixth RTD test. Also, throughout the testing process a number of modifications were made to the RTD pneumatic and electrical systems to increase the angular acceleration imparted to the vehicle<sup>5</sup>. The RTD structure was also upgraded to improve stability, including larger axles and wheels which were used in the last two RTD tests. These additional modifications improved the RTD's operation and increased the test vehicle's angular velocity at release.

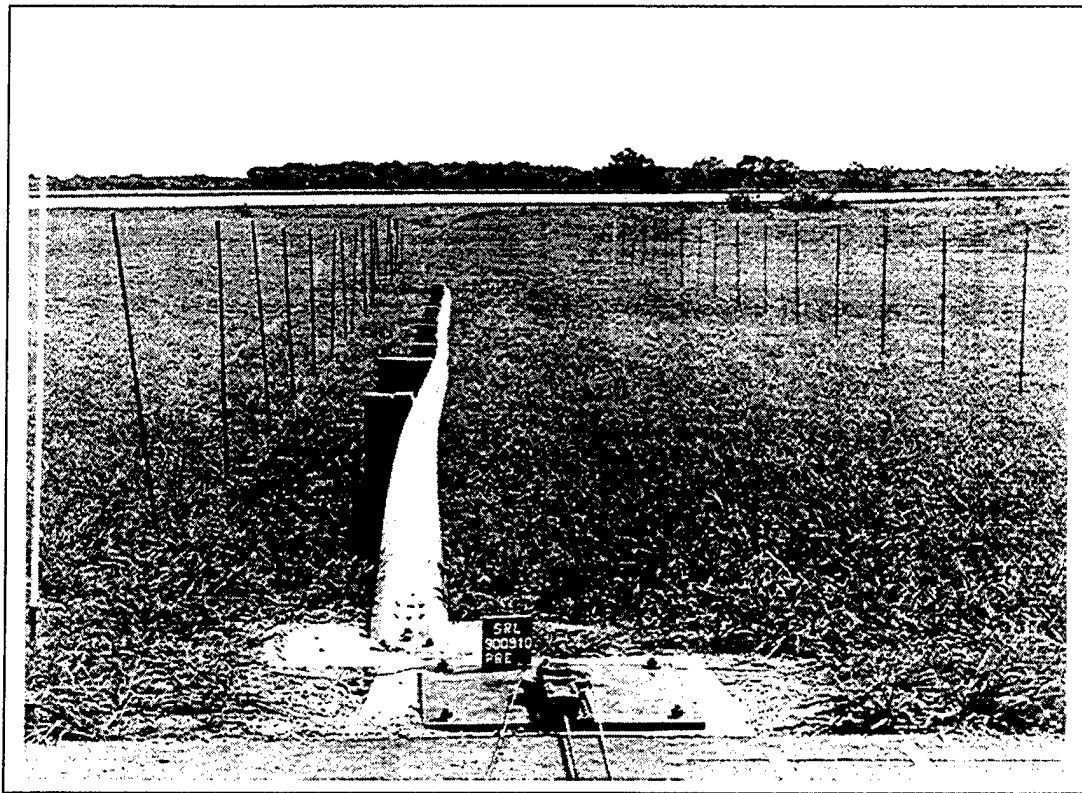
Figure 4. Guardrail Construction

In the guardrail impact tests, the vehicle was towed by cable about a pulley to obtain the specified initial velocity. A stationary cable was used to control any lateral movement of the vehicle. Several feet in front of the guardrail, the vehicle was released from the towing cable and allowed to run up the turned down end of the guardrail (Figure 4). The guardrail was positioned to be 15 inches offset from the vehicle centerline on the driver's side. The guardrail forced the vehicle upward and induced a rolling moment. A grass surface surrounded the guardrail. The complete test layout for the G2 and G3 guardrail impact tests is depicted in Figure 5. A similar test layout was used for the G1 guardrail impact test which had a dirt and grass test area.

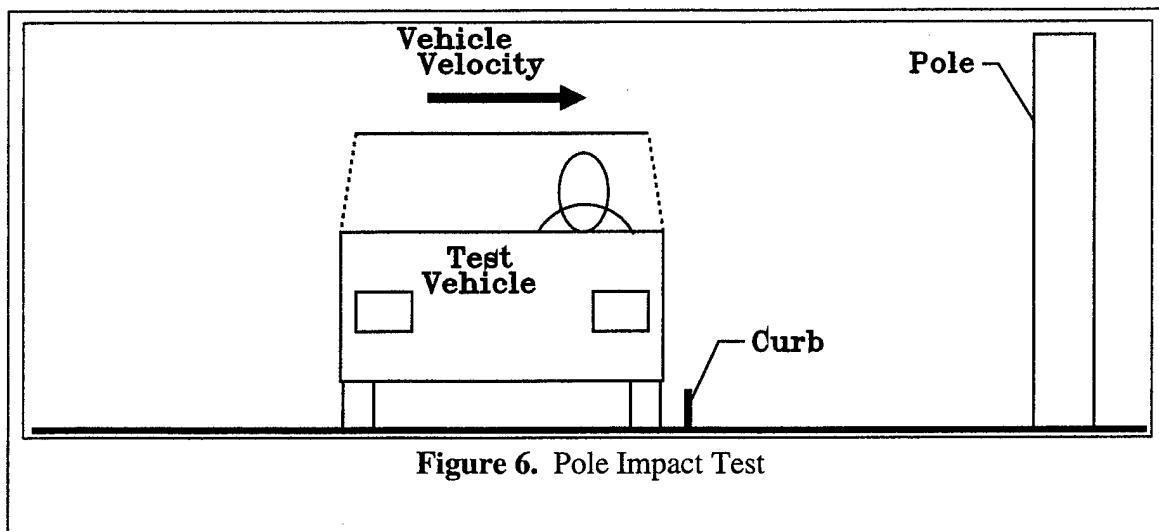
In the pole impact tests, the vehicle was towed laterally by cable on an asphalt surface to obtain the specified initial velocity. The surface was soaped to allow the vehicle's wheels to slide without the vehicle becoming unstable. Immediately prior to impact, the vehicle was released from the cable. The initial impact was between the driver's side wheels and two eight-inch-high steel plate curbs. As shown in Figure 6, the curbs were positioned to initiate the vehicle's roll. A 12-inch diameter instrumented steel pole was positioned 75.5 inches beyond the curbs. The pole was placed approximately aligned with the vehicle's longitudinal center of mass and at a distance from the curbs that would cause the vehicle to impact the pole during its rolling motion.

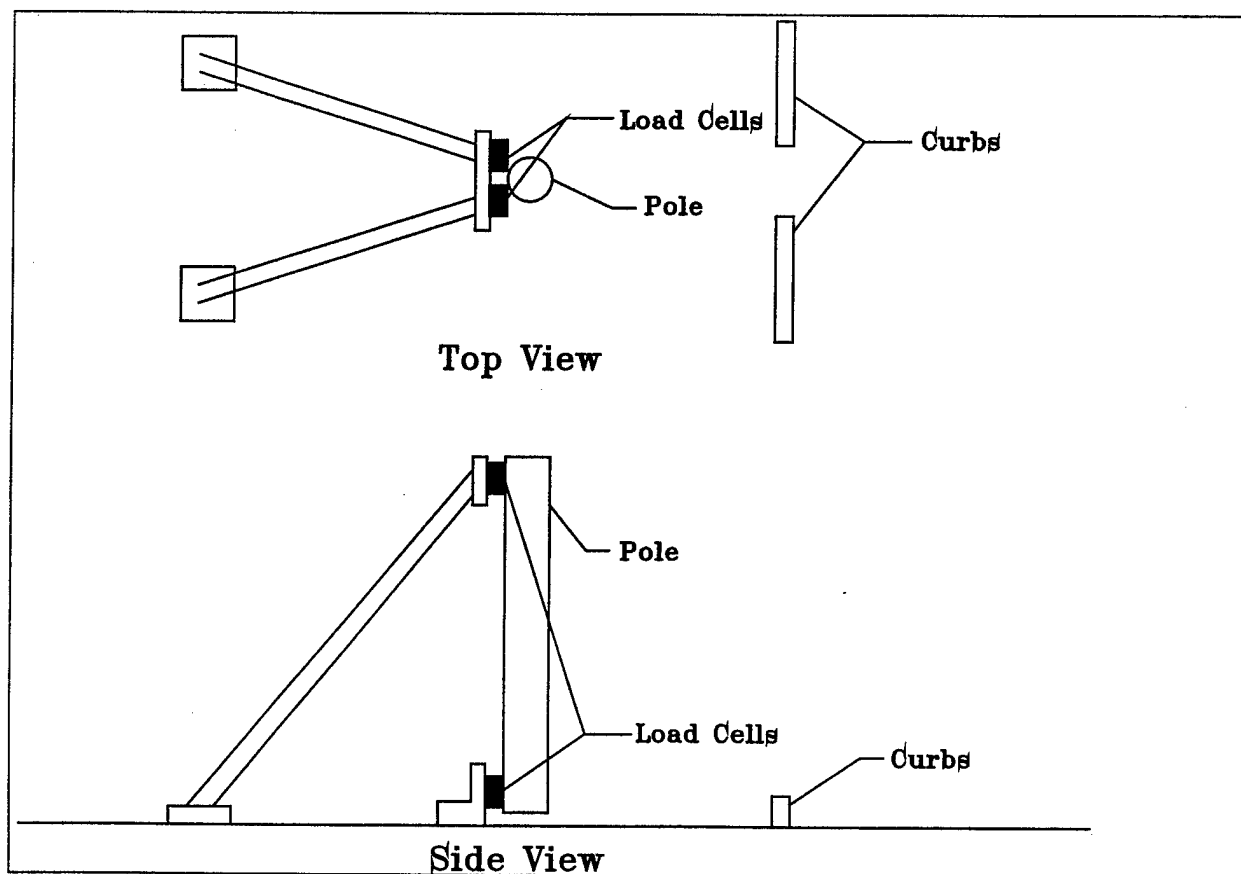
Figure 7. Pole Load Cell Locations

When used, the RTD was instrumented to collect the three-dimensional acceleration of the RTD and the platform displacement at each cylinder. Also, limit switches were used on both sides of the vehicle to measure the vehicle/RTD separation times. The pole in the pole impact tests was instrumented to measure the forces acting on it. Figure 7 shows the location of the four pole load cells. All the vehicles were instrumented to collect the three-dimensional vehicle center of mass accelerations and angular velocities. Also collected were the suspension displacements at all four wheels. The locations and coordinate systems for the vehicle instrumentation are listed in Table 3. Part 572 (Hybrid II) dummies were used in the first three tests and Part 572E (Hybrid III) dummies were used in the subsequent tests. The dummies were instrumented to collect three-dimensional head, chest and pelvis accelerations, three-dimensional neck forces and moments, and chest displacement. Femur loads were also measured in some of the earlier tests. The locations and coordinate systems for the dummy instrumentation are listed in Table 4. When the dummy was restrained, the belt displacement at the belt feed-out point was also measured. A description of the data filtering used for these tests is included in Appendix A.

Test #	Vehicle	Maximum Pole Load (lb)			
		Top Left	Top Right	Bottom Left	Bottom Right
P1	Dodge Caravan	-5,400	-5,800	-10,100	-5,300
P2	Nissan Pickup	-1,900	-4,000	-4,000	-5,000

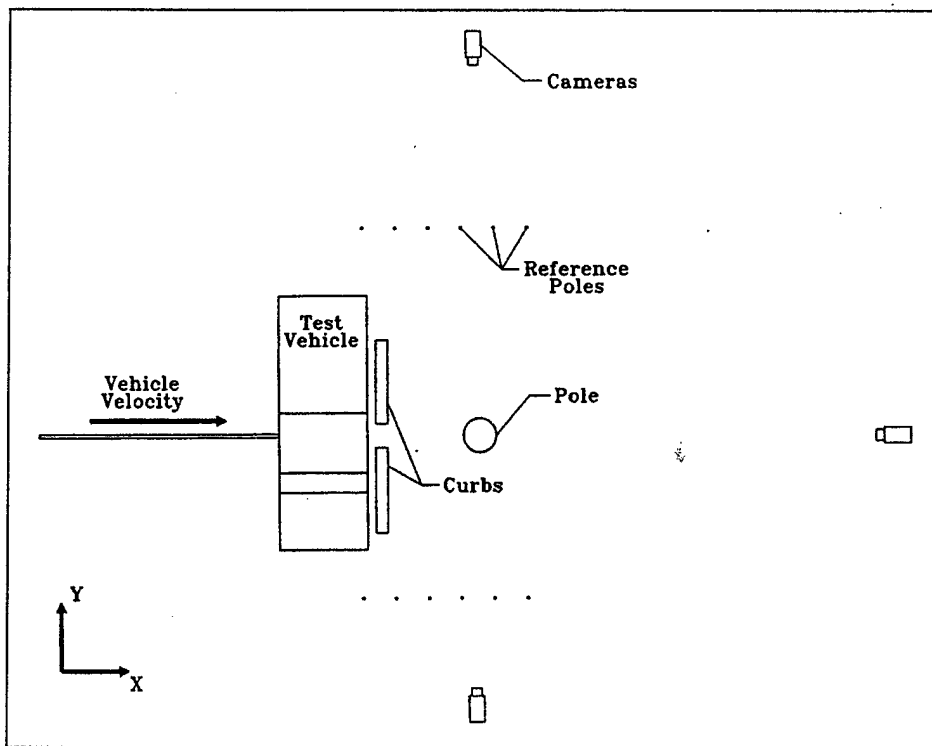
Figure 8. Pole Impact Test Layout

High speed cameras were used to film both the vehicle and dummy motion. Typically, three exterior cameras were used in the RTD tests as shown in Figure 2 to film the vehicle motion. Four exterior cameras were used in the pole impact tests, including an overhead camera not shown in Figure 8, and five cameras were used in the guardrail impact tests (Figure 5). A panning camera was also used to provide a real-time film of the vehicle motion. Whenever possible, two interior cameras were used to film the dummy motion. The front interior camera was mounted laterally opposite to the dummy in a position unlikely to affect the dummy's motion. Usually this camera was mounted to the floor, in front of the seat and focusing up towards the dummy. The second interior camera was mounted in the back seat or compartment with the field of view covering the whole front seat compartment in case the dummy moved laterally across the vehicle. This camera was not used in the tests using pickup trucks, due to the lack of a safe mounting position. Break-away reference poles were placed throughout the test areas to provide a gauge for measuring the vehicle motion from the films.

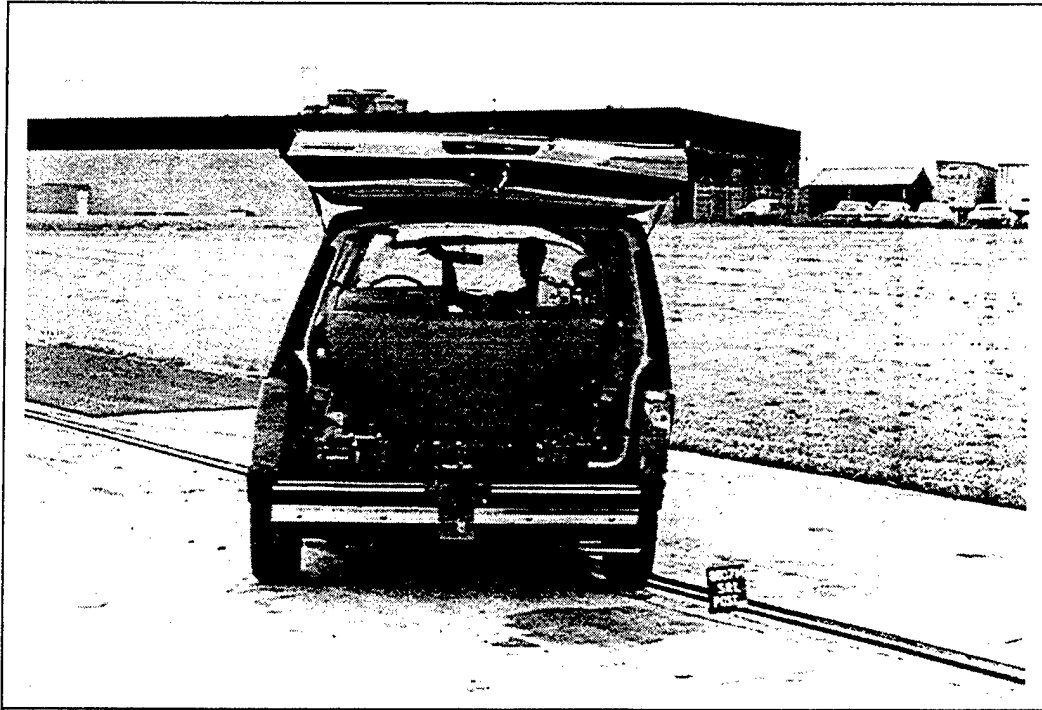
**Figure 9.** Test D8 Dodge Caravan Damage

longitudinal axis after this initial impact. A maximum roll of two complete revolutions was obtained in two of the tests. Table 7 lists the general vehicle motion and the major damage to the vehicles. In many of the tests, especially those with pickup trucks, the A-pillar and B-pillar on the impact side collapsed during the first impact with the ground. As the trucks continued to roll, the roof collapsed as it contacted the ground. Most of the pickups slid to a stop on their roof, while some still had enough angular kinetic energy to roll back onto their wheels. The Dodge Caravan in test D8 landed on its side and slid without rolling any further. Although the maximum crush appears to be relatively small, 7.4 inches, the whole van structure was deformed (Figure 9), while in the other van tests only the roof sustained serious damage. Many of the vehicles that came to a rest on their wheels stopped rolling because one or more of the tires blew out, absorbing energy. Other vehicles' suspension systems caused the vehicle to bounce and continue rolling. These results suggest that the primary factor that affected the amount of roll was the energy absorbed in the vehicle deformation.

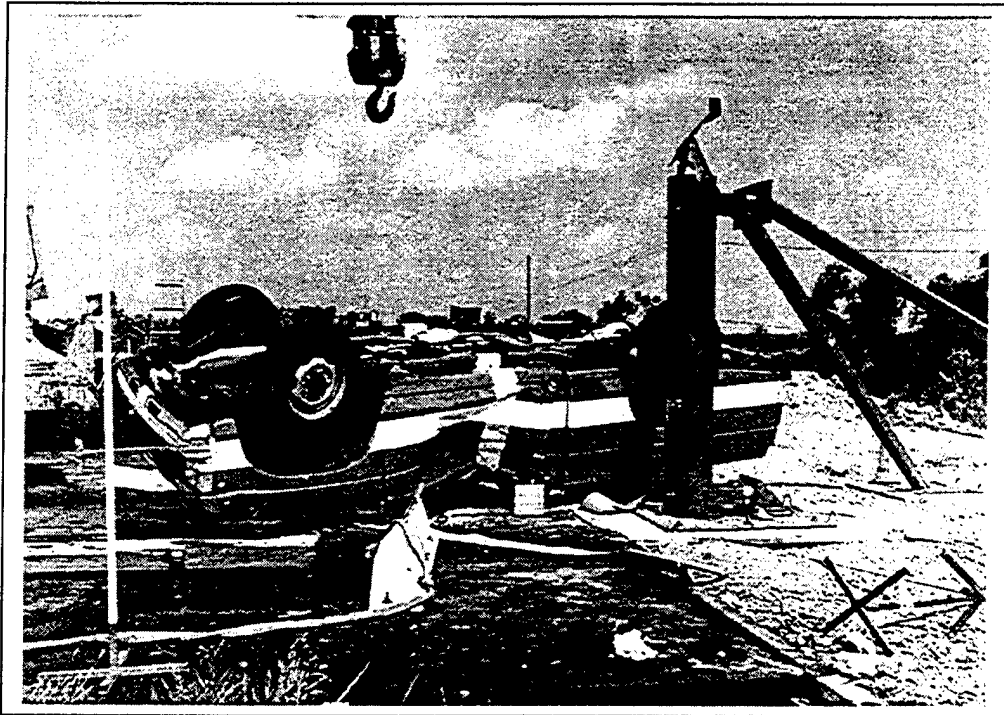
**Figure 10.** Dodge Caravan Pole Impact Test Final Position

material was changed from concrete to steel to avoid curb failure. Also the impact velocity was varied to investigate its effects. The curb in the P1 pole impact test did initiate significant roll and the Caravan impacted the pole after rolling approximately 45°. The driver's side and roof sustained major damage as the vehicle wrapped itself around the pole (Figure 10). The same conditions were used in the P2 pole impact test, but the Nissan Pickup behaved differently. Upon impact with the curb, the truck flew more than six feet into the air and quickly rolled completely upside down. As the vehicle started to come down, the right passenger side hit the pole, causing the pickup to yaw about the pole. The pickup landed upside down on top of its rear wheel, which broke free during the curb impact (Figure 11). The maximum loads on the pole are listed in Table 8. In both tests the impacting wheels suffered major damage, as they were bent at the axle. These results demonstrate the difficulty in predicting the vehicle response in this test configuration and the resulting difficulty in choosing the test conditions. When the curb was not high enough or the velocity was too high, the wheels skipped the curb and no rolling motion occurred. Other conditions caused the wheels to be stopped, transferring all the linear kinetic energy to angular kinetic energy, and the vehicle would fly into the air, rolling rapidly with little forward motion. The ideal vehicle response would have been for the wheels to skip the curb, while slowing down enough for the rest of the vehicle to roll over them, initiating enough rolling motion to tip the vehicle just before impact with the pole.
